West Broadway Urban Village
 Infrastructure Improvements Project
 City of Seaside
 Project No. 2016-76
 Federal No. ATPL-5316 (007)

Report No: **13**
 Date: **06/20/17**
 Day: **Tuesday**
 Shift Hours: Start **0800**
 Stop **1600**

ASSISTANT RESIDENT ENGINEER'S DAILY INSPECTION REPORT

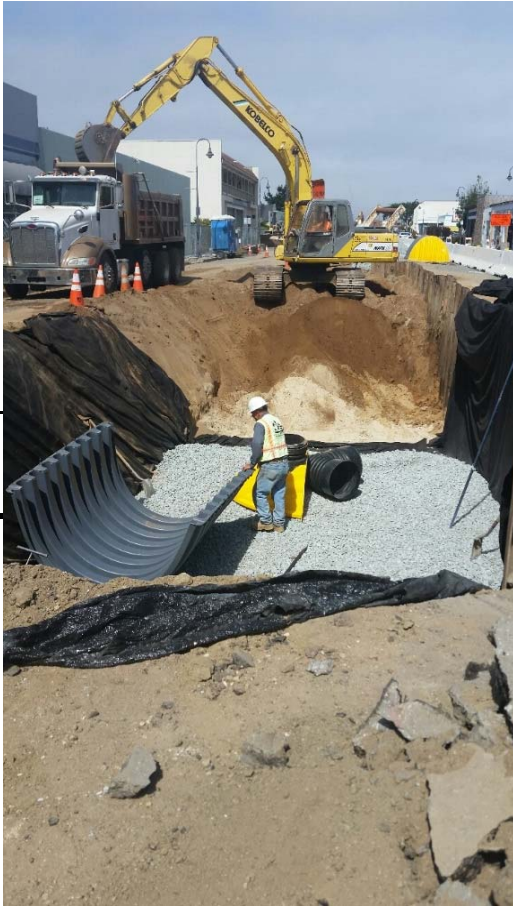
start of Infiltrator #2 installation

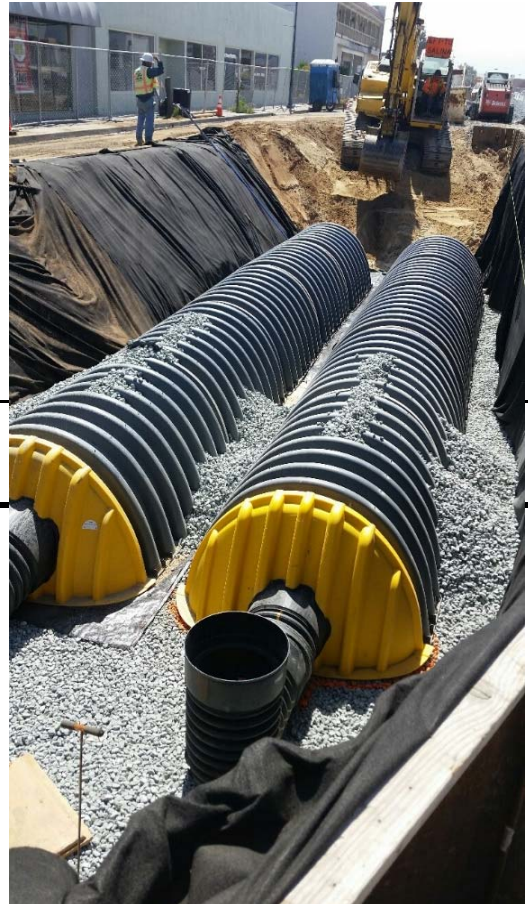
Infiltrator #2 manhole end
