West Broadway Urban Village
 Infrastructure Improvements Project
 City of Seaside
 Project No. 2016-76
 Federal No. ATPL-5316 (007)

Report No: **54**
 Date: **08/21/17**
 Day: **Monday**
 Shift Hours: Start **0700**
 Stop **1530**

ASSISTANT RESIDENT ENGINEER'S DAILY INSPECTION REPORT Page 1 of 2

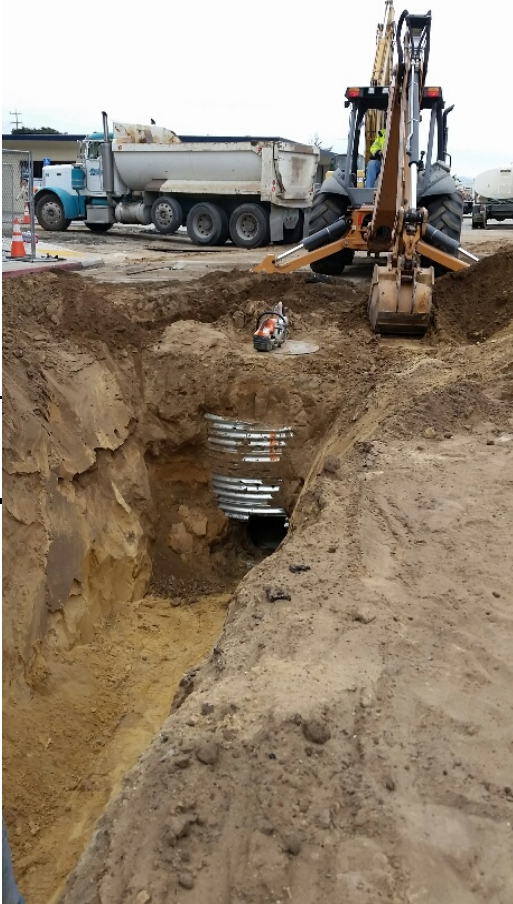
Excavating for Drainage Structure 6d, 12" HDPE pipe

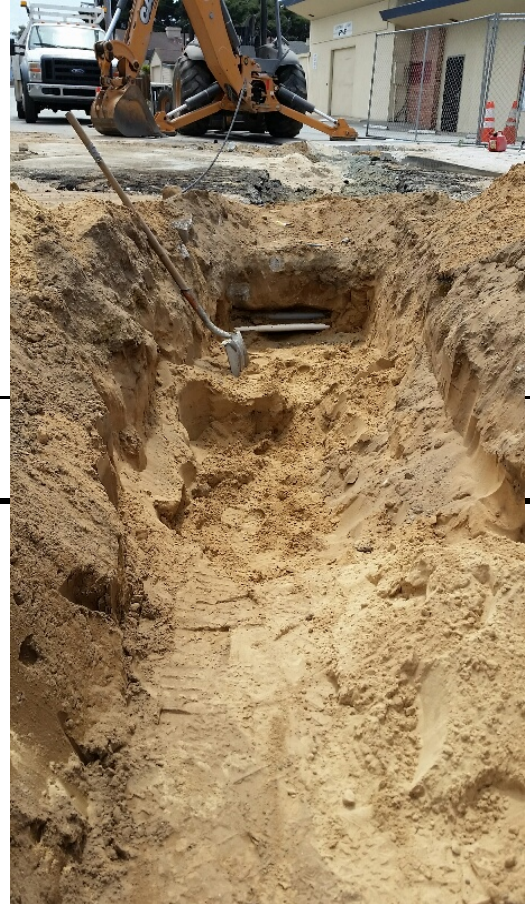
Irrigation and electrical conduit at same elevation as DS 6d
