West Broadway Urban Village
 Infrastructure Improvements Project
 City of Seaside
 Project No. 2016-76
 Federal No. ATPL-5316 (007)

Report No: **65**
 Date: **09/06/17**
 Day: **Wednesday**
 Shift Hours: Start **0700**
 Stop **1530**

ASSISTANT RESIDENT ENGINEER'S DAILY INSPECTION REPORT Page 1 of 2

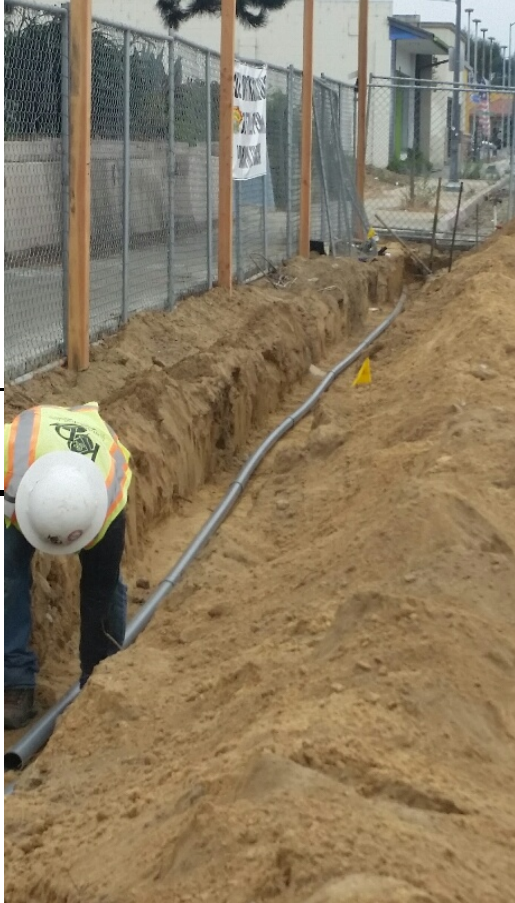
Irrigation trench and electrical conduit, west of Hillsdale St

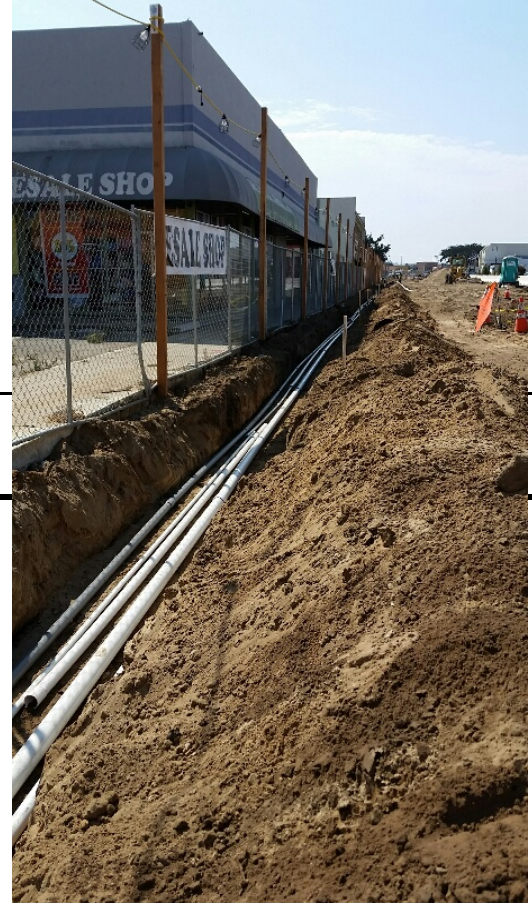
Irrigation trench with electrical and water conduit,
west of Alhambra St
