West Broadway Urban Village  
 Infrastructure Improvements Project  
 City of Seaside  
 Project No. 2016-76  
 Federal No. ATPL-5316 (007)

**ASSISTANT RESIDENT ENGINEER'S DAILY INSPECTION REPORT** Page 1 of 2

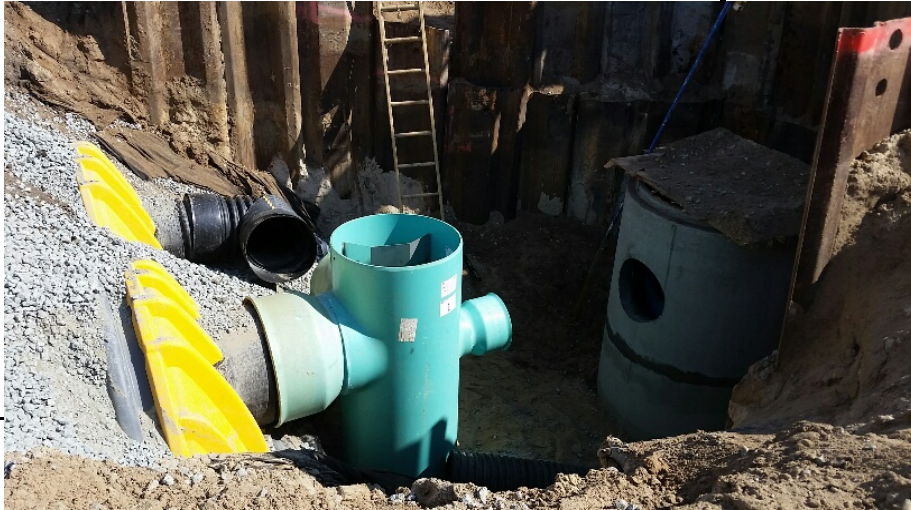
Hydrodynamic Separator #1, weir, and exposed infiltrator, before backfill

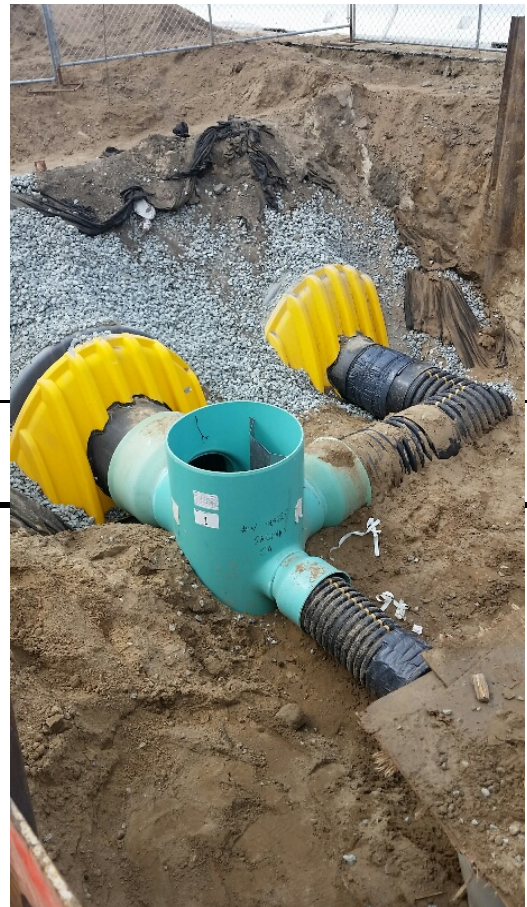
At HDS #1, MPE installed HDPE pipe to connect the weir to the infiltrator (18" + elbow) and the HDS to the weir (12"). Backfill placed and compacted at bottom of the pipes. K&D Landscaping continued irrigation conduit installation as follows: 3" pipe sleeve with 2 each 3/4" pvc pipes inside (for bubbler and drip irrigation); and a 2" pipe sleeve for 1" pvc pipe for bioswale irrigation. Later, trenches were backfilled. DVE marked electrical conduit runs and pull boxes, then trenched to 2.5' deep. DVE placed 3" rigid electrical conduit in trench from Alhambra westward toward Hillsdale. Traffic control devices were operational; dust monitored and controlled with water multiple times during the day. Backfill piles were left below k-rail level to prevent dust migration to the north side of Broadway.

Pipe connections between HDS #1, weir and infiltrator partial backfill only
